APPENDIX D PROBLEM AREAS AND OBSTRUCTIONS

PROBLEM AREA IDENTIFICATION

Municipalities Reporting Problem Areas and Obstructions
 Dauphin County Act 167 Plan
 Dauphin County, PA

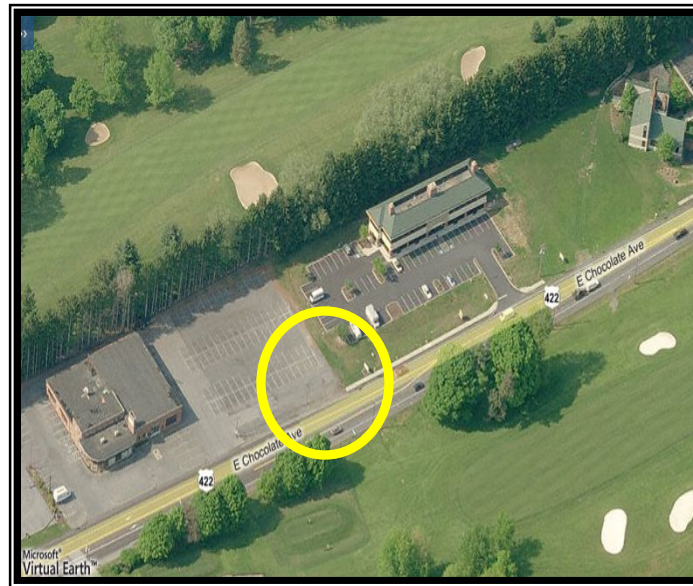
- Flooding of Route 422 and the parking lot by the car dealership (Chevrolet of Hershey) have been reported (Photo 1 and Drawing No. 1). There is an existing catch basin in the vegetated area between the auto dealership and the Highmark building on the north side of Route 422 (Photo 2).
- Stormwater runoff that enters the existing catch basin is conveyed by an 18-inch diameter pipe under Route 422, where the flow is discharged to open ground on the Spring Creek Golf Course (Photo 3).
- The existing pipe does not have enough capacity to drain all the stormwater reaching the inlet efficiently during large storm events. In addition, the inlet is not located at the lowest point in the grassy swale area. Storm runoff ponds in the grassy area and the corner of the parking lot.
- Water also ponds on E. Chocolate Avenue at a low point just west of the inlet, creating a traffic hazard.

Photo 1 - Aerial View of Problem Area D1

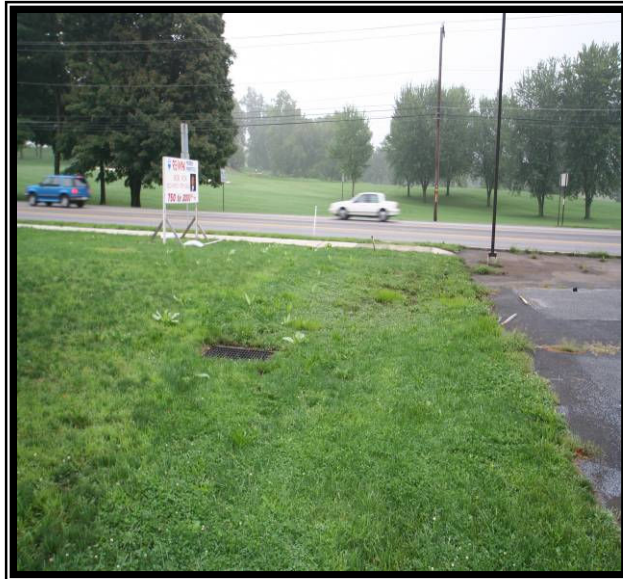
Photo 2 - View of the stormwater catch basin

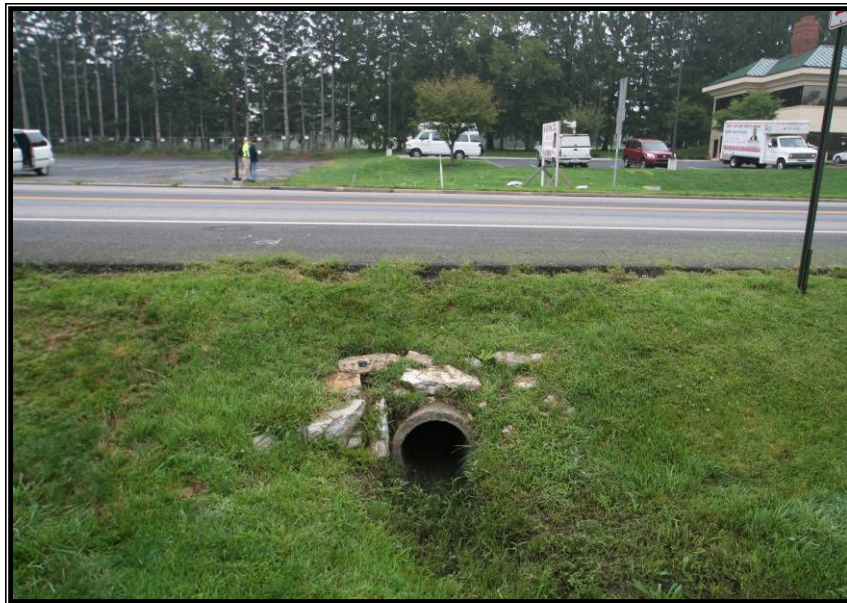
Photo 3 - Existing 18-inch pipe under Route 422

- The drainage area that is contributing to this site is about 10-acres (0.02-square miles).
- A short term economical solution to alleviate some of the nuisance ponding of stormwater runoff would be the addition of another stormwater catch basin, and connection to the existing conveyance system.
- It will be necessary to add an additional inlet at the low point of E. Chocolate Avenue and replace the 18-inch pipe under Route 422 (Photo 3) to eliminate the ponding and flow of storm runoff along E. Chocolate Avenue. A preliminary analysis shows that a 30-inch pipe could pass the 50-year storm event.

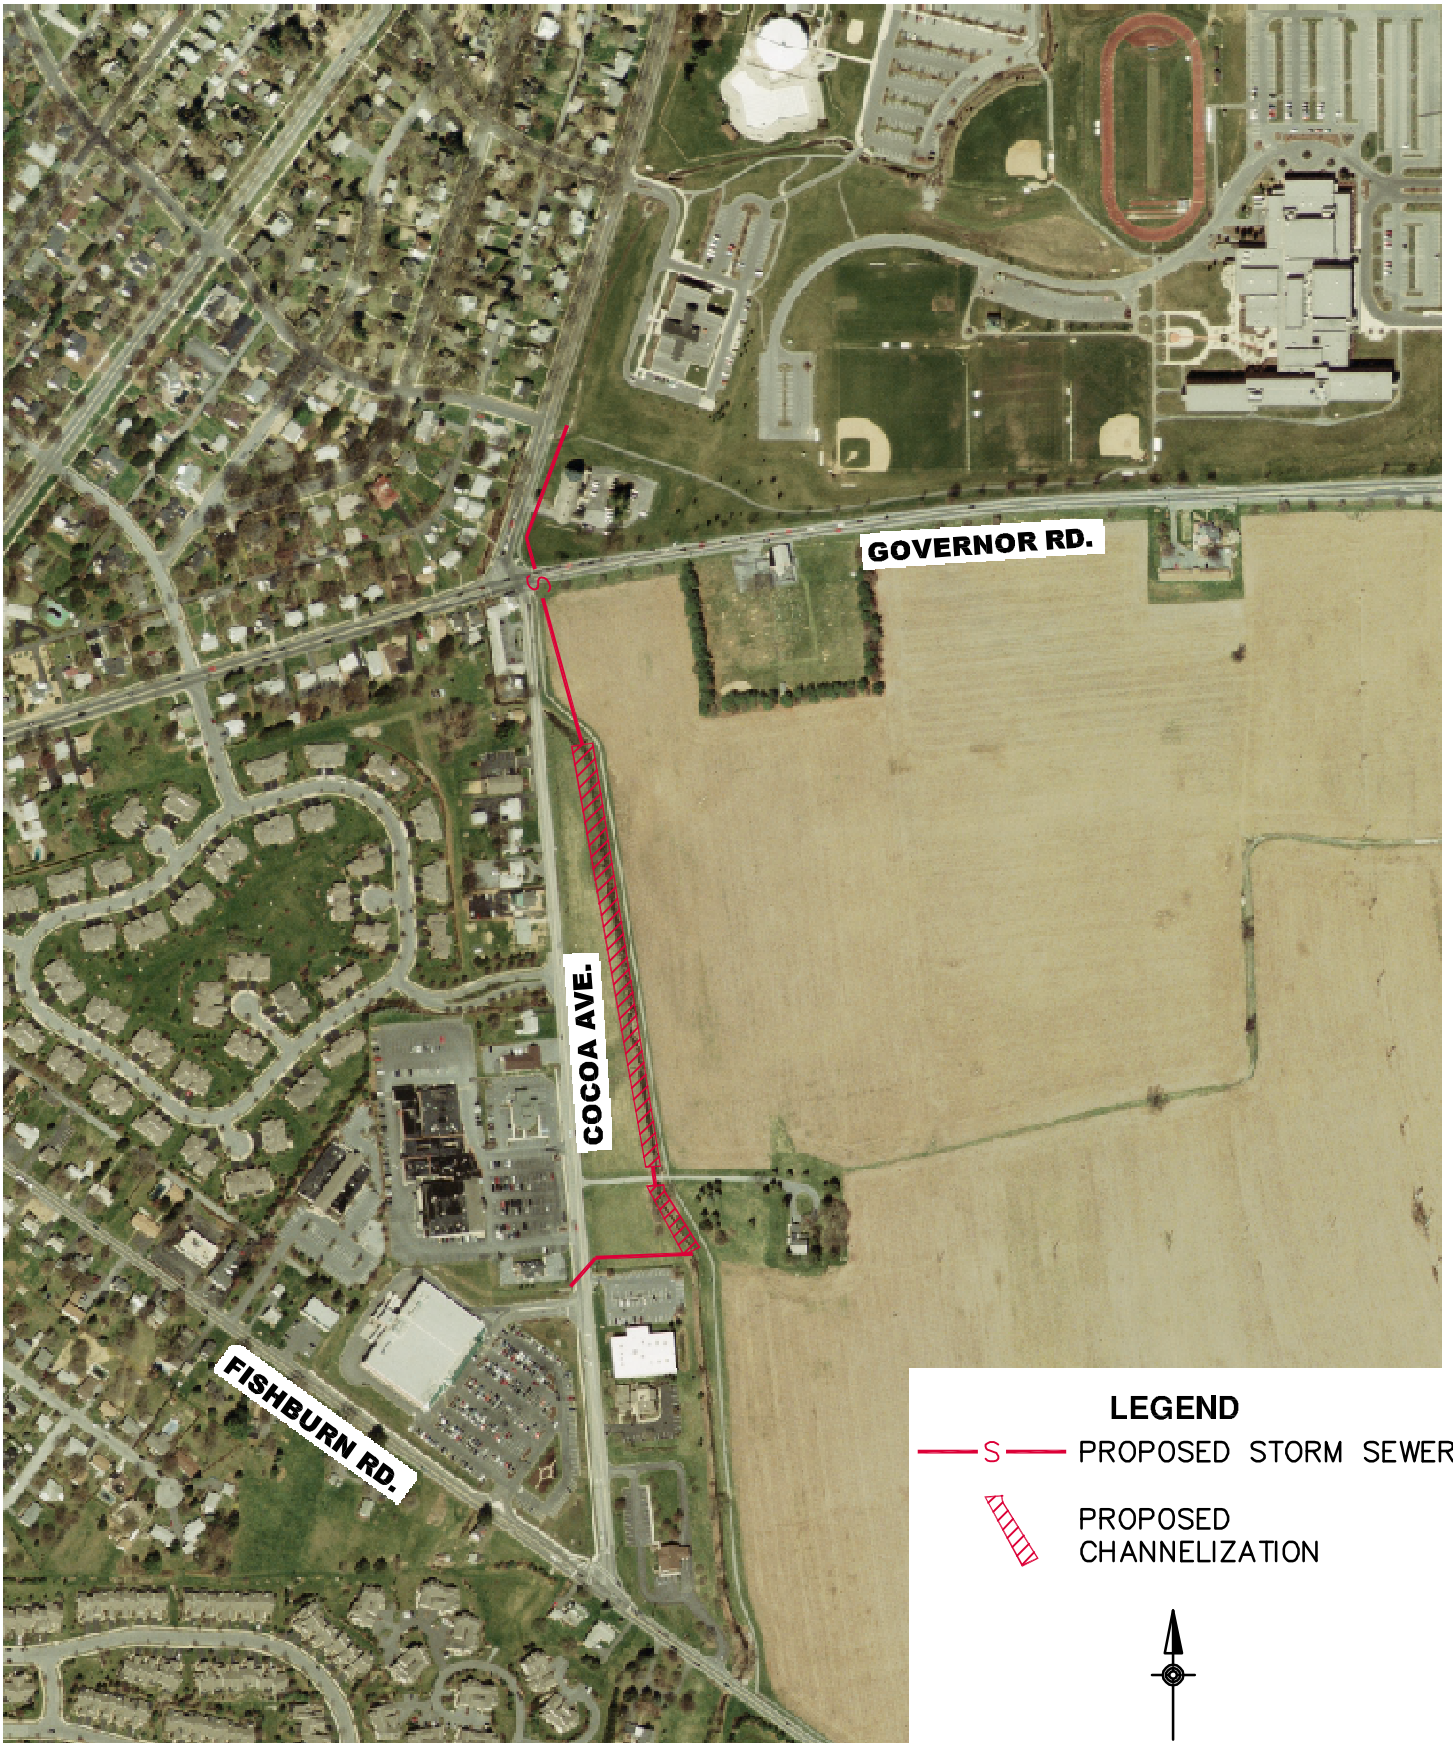
DRAWING NO.
2
SHEET NO.
OF
PROJECT 1203.0013

- Flooding and channel erosion have been occurring along Cocoa Avenue, in the shopping center parking lot, and on several private properties near Governor Road. The primary cause of these problems is the lack of capacity in various roadway culverts and stream channels (Table 5 and Drawing No. 2). The other reason is due to flooding of the stormwater catch basins located along the roadway. The catch basins discharge to the east, via a box culvert under Cocoa Avenue, into an adjacent field where discharge is conveyed via a swale into a tributary of Spring Creek (East). The receiving swale, which carries stormwater runoff appears to be full of sediment, and does not function as intended. As a result, the drainage system does not operate properly.

PROPOSED IMPROVEMENT	RECOMMENDED FACILITY
Culvert under Cocoa Avenue near Fulton Bank	One (1) - 48" CMP, 275' Long
Culvert under private driveway	Two (2) - 66" CMP, 20' Long
Culvert under Governor Road	Two (2) - 72" CMP, 800' Long

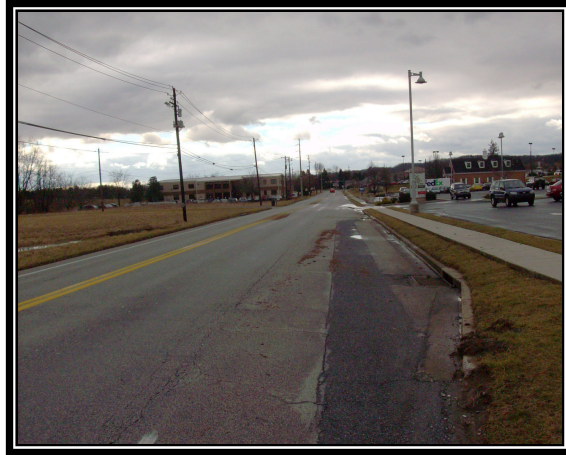
- The culvert located under Cocoa Avenue does not have enough capacity; therefore, flooding of Cocoa Avenue between Governor Road and Fishburn Road has been reported. In addition, erosion (Photo 4) was observed in the swale adjacent to Fulton Bank (Photo 5).

Photo 4 - Looking south on Cocoa Avenue

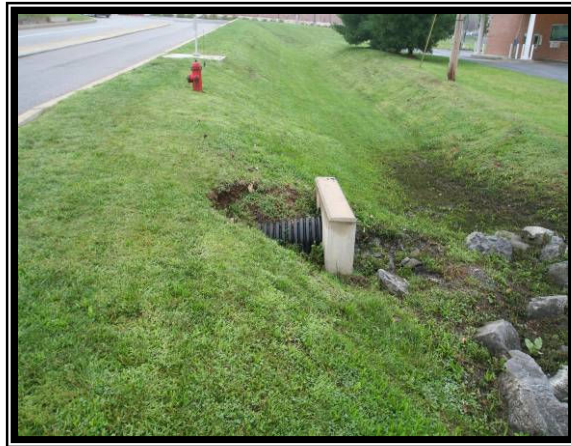
Photo 5 - Eroded endwall by Fulton Bank west of Cocoa Avenue

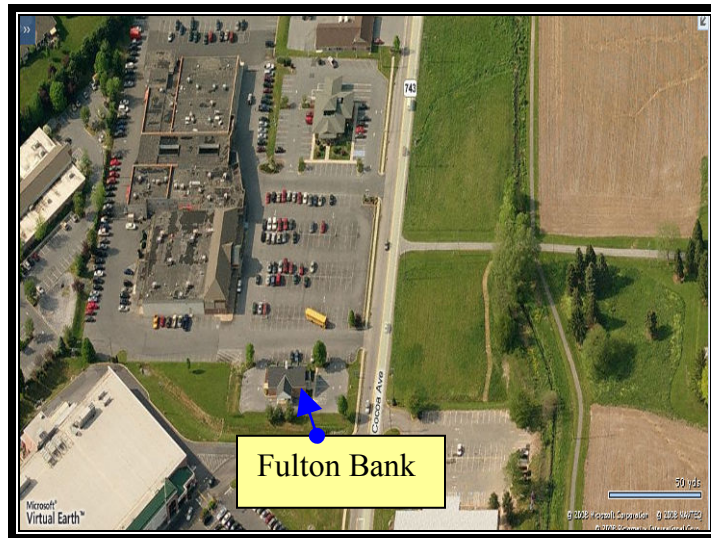
Photo 6 - Aerial view of Cocoa Avenue

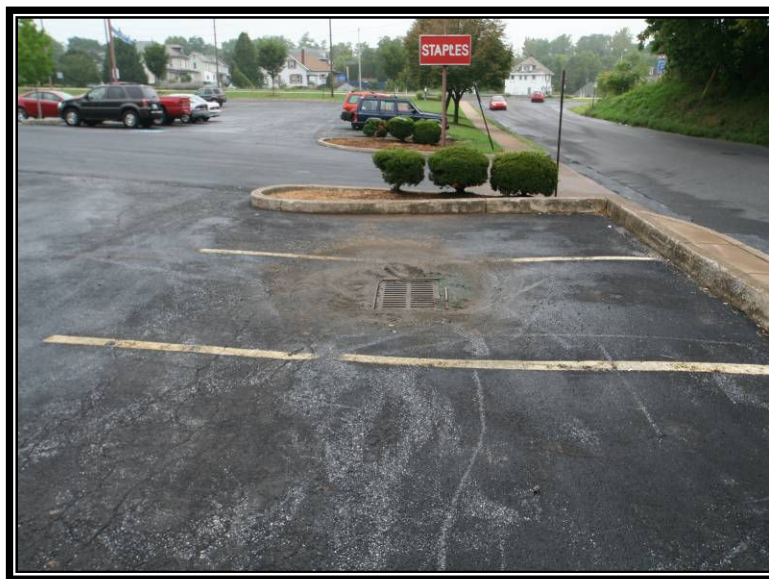
Photo 7 - Sedimentation and Flooding Problems at STAPLES

- Clean the sediment from the stormwater catch basins and pipes in the shopping center parking lot.
- Install a new storm sewer parallel to the existing storm sewer with inlets and pipes of sufficient supplemental capacity, so that together, the existing and proposed system can handle the 50-year return frequency storm event. Drawing No. 3 illustrates the approximate alignment of the new sewer system. Assuming an average proposed system slope of 1.0 percent, the proposed storm sewer ranges in size from 30-inches between Governor Road and Cedar Avenue, 48-inches between Cedar Avenue and Route 422, and 60-inches from Route 422 to the quarry outfall.

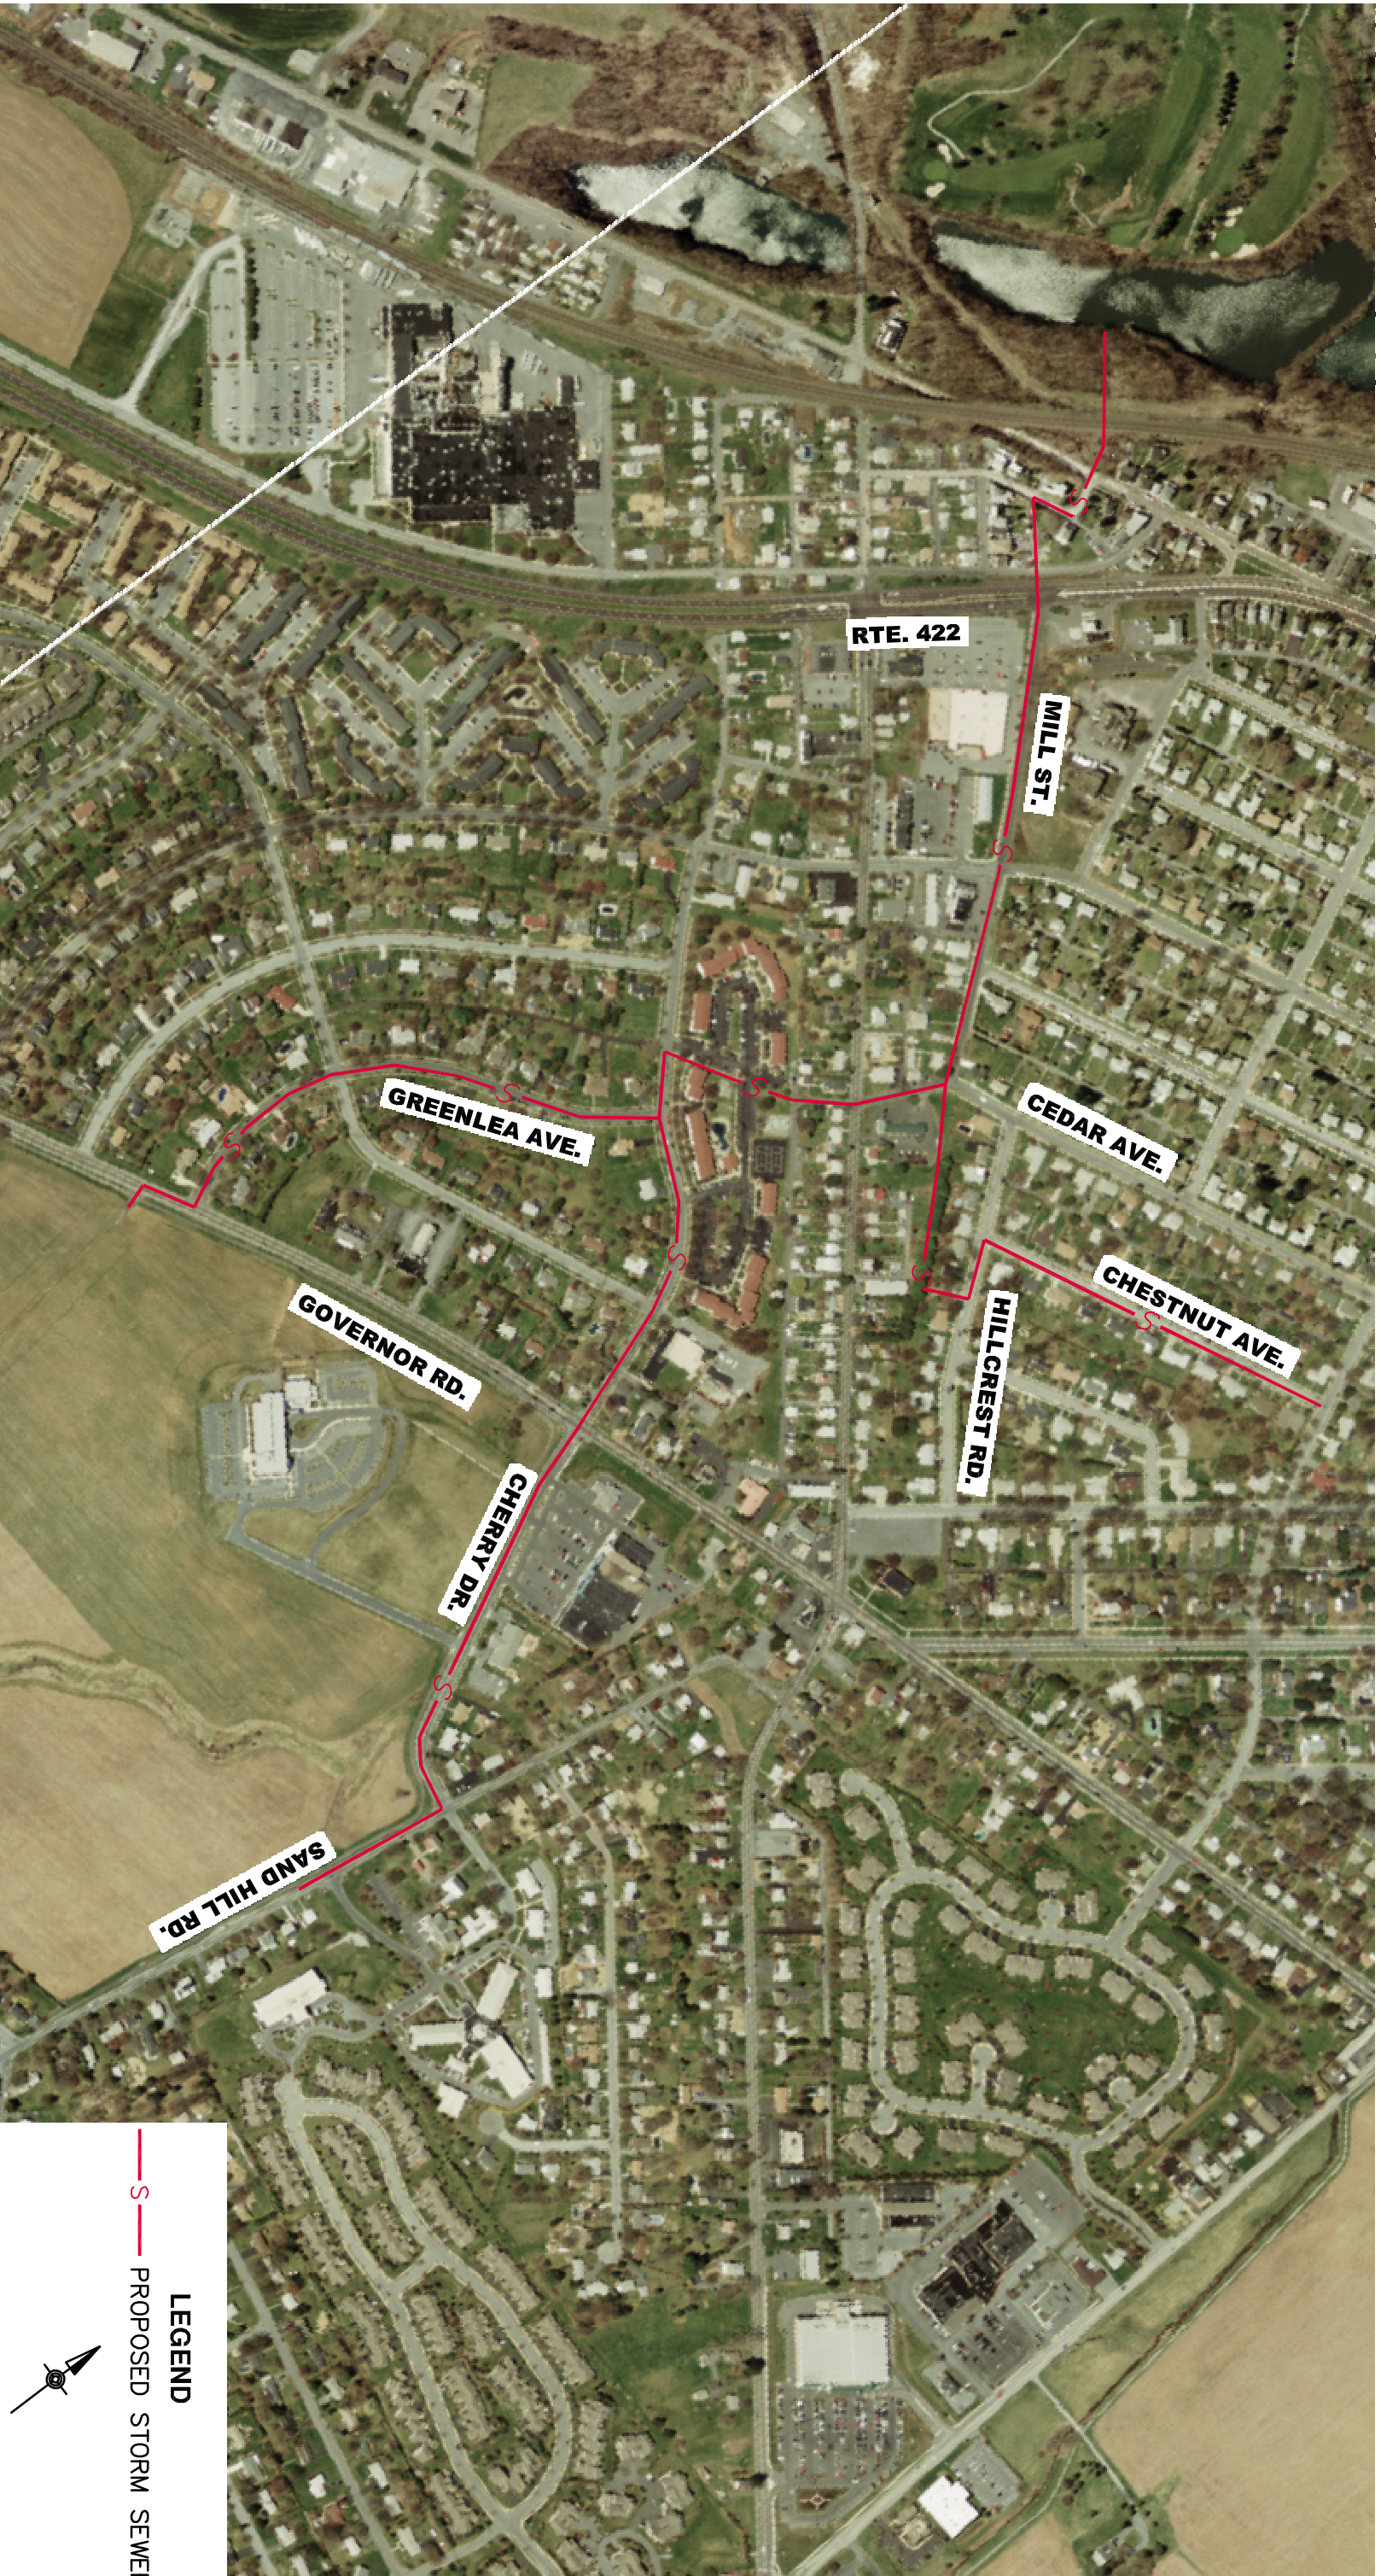
- Flooding of buildings, streets and parking lots in the area of Mill Street and Cherry Drive has been reported (Photo 7 and Drawing No. 3).
- There is an existing storm sewer that runs northward under Mill Street and Cherry Street from Governor Road (Route 322) to a discharge point at the quarry ponds north of the railroad tracks.
- The contributing drainage area at the quarry discharge point is approximately 1.04-square miles, at Route 422 it is 0.95-square miles, and at the intersection of Governor Road and Cherry Street it is 0.51-square miles.
- The existing storm sewer system is undersized for the level of existing land development and the amount of impervious cover in the contributing watershed.

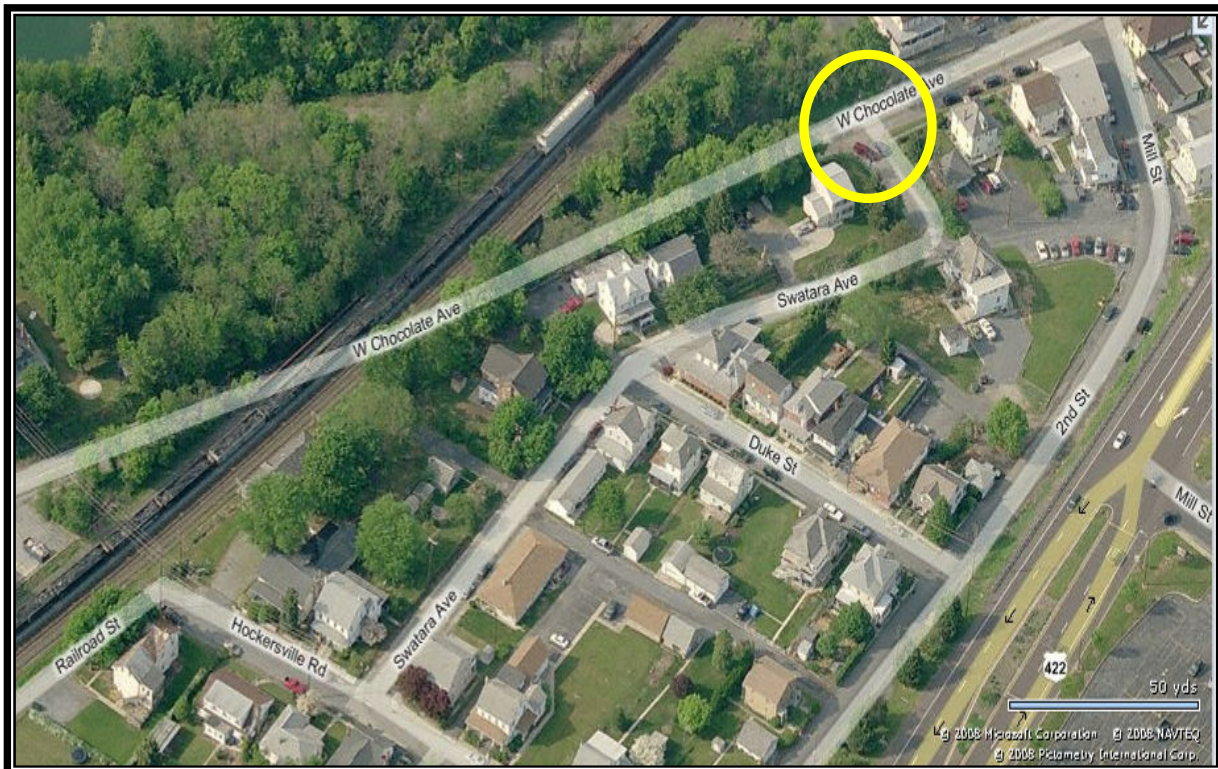
- West Chocolate Avenue has experienced several flooding events at the intersection with Swatara Avenue.
- The intersection of West Chocolate and Swatara Avenues is a low spot of the roadway (Photo 8 and Drawing No. 4). There are no stormwater catch basins at the low point, so stormwater runoff ponds until it either infiltrates or evaporates. The drainage area contributing to this low spot is approximately 10-acres.

PHOTO 8 - Aerial View of the intersection of Swatara Avenue and West Chocolate Avenue

- Install stormwater catch basins, and a 30-inch storm sewer that would tie into the recommended storm sewer system of Problem Area D3 – Mill/Cherry Streets (Drawing No. 3).

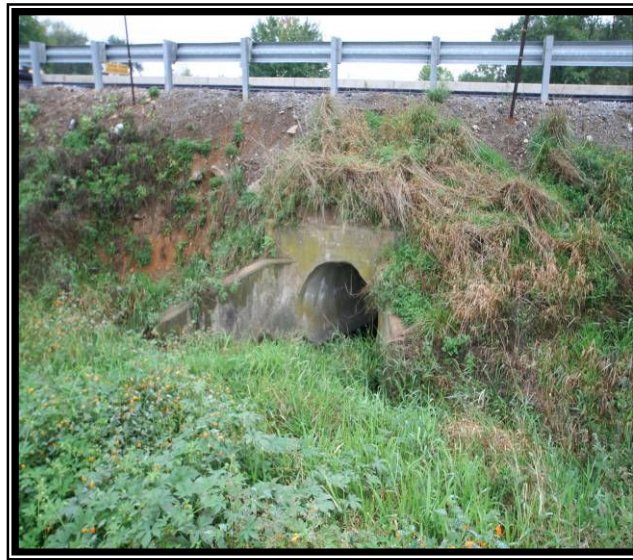
- A flooding problem has been reported along Bullfrog Valley Road at the Route 422/322 interchange.
- The drainage system is comprised of an unnamed tributary to Swatara Creek running south to north that roughly parallels Bullfrog Valley Road from south of Wood Road to the Route 322/422 interchange (Drawing No. 5).
- There is also another tributary that collects runoff from east of Bullfrog Valley road and enters the Route 422/322 system via a culvert under the roadway just downstream of the large stormwater detention pond on the Hershey Hospital grounds.
- There is a series of 48-inch pipes under the Route 422/322 interchange (Photo 9).

Photo 9 - Upstream end of the existing culvert under the Route 322 ramp

- The results of a preliminary analysis show conveying the 25-year event requires a total of three (3) 48-inch pipes under each ramp and the main roadway of the Route 322/422 intersection (Drawing No. 5) for the stream paralleling Bullfrog Valley Road and a single 48-inch pipe under Bullfrog Valley Road and Route 322 for the tributary.

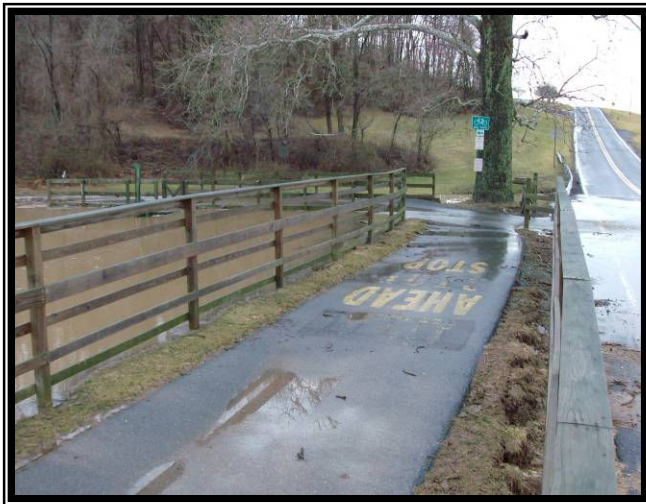
- Flooding of Wood Road near the intersection with Bullfrog Valley Road has been reported (Photo 10 and Drawing No. 6).
- The right bank of the stream that flows under Wood Road has been significantly eroded just upstream of the pedestrian bridge. Gabion baskets placed in the stream have been eroded around at their tie-in location within the stream banks (Photo 11).
- During flood events, the pond located near the intersection of Wood Road and Bullfrog Valley Road has been inundated and stream flow has overtopped Wood Road. The standpipe installed in the pond appears to be undersized and does not function properly. The pond's emergency spillway elevation and width is inadequately sized to prevent the stream flow from overtopping the pond, eroding the embankment, and flooding Wood Road. The pipe carrying flow from the emergency spillway under Wood Road also has insufficient capacity.

Photo 10 - Flooding of the Wood Road Pond

- To minimize the flooding conditions that have been experienced periodically, it is recommended that the culvert under Wood Road be replaced (Drawing No. 6), and the short segment of storm sewer just north of Wood Road be removed. This will require relocating a major water pipeline that parallels the north side of Wood Road. The existing gabion weirs upstream of the pond on the south side of Wood Road should be evaluated for their impacts on flooding and stream meandering and the eroded channel should be repaired.

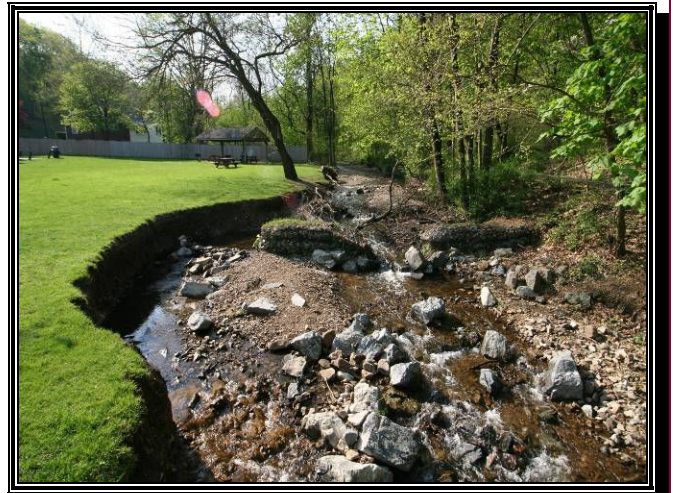
Photo 11 – Erosion at gabions upstream of pond

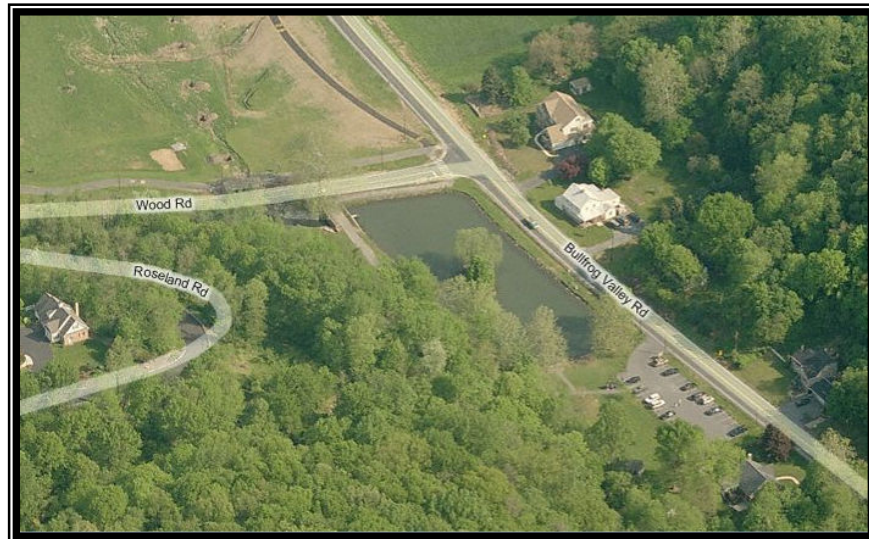
Photo 12: Aerial View of Wood Road

- In addition to the culvert replacement at Wood Road, it will be necessary to improve the channel flood capacity downstream of Wood Road for the design storm event. The low flow channel was designed to handle the 2.33-year return period flow (often referred to as the annual average flow rate). The overbank flow area north of Wood Road should be designed to handle the 50 year return period flow once the storm sewer is removed (Table 7).

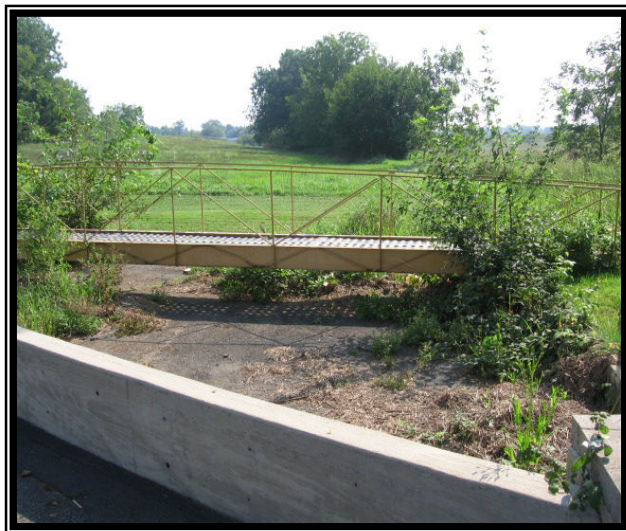
- Flooding of Sunset Drive and the mobile home park located south of Caracas Avenue (Drawing No. 7).
- According to the Township records, some sinkholes developed after 1949. This development may have altered the hydrology of Spring Creek (East) at this location. After large storms, the stream flows through its original route down Sunset Road. Since the capacity of the stormwater system is not large enough to deal with large storms, Spring Creek floods Sunset Drive and the mobile home park (Photos 13, and 14).

Photo 13 - The concrete wall that is supposed to protect the park from floods.

- The drainage area contributing to this site is about 3.66-square miles.
- As illustrated on Drawing No. 7, it is recommended to install a storm sewer that would have a headwall or stormwater catch basin at the east (upstream) end of Sunset Drive, and then run under Sunset Drive and through a farm field to discharge into Spring Creek, approximately 500-feet west of the west end of Sunset Road. The total system length of the main storm sewer would approximately be 1,200-feet. There would be four (4) stormwater catch basins along Sunset Drive to collect lateral inflow. The main storm sewer would require two (2) 60-inch HDPE pipes to convey the 50-year return frequency storm event peak discharge.

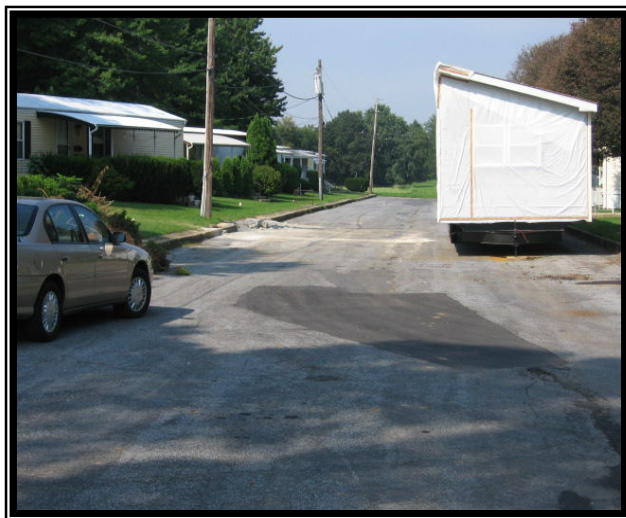
Photo 14 - Mobile Home Park and Sunset Drive

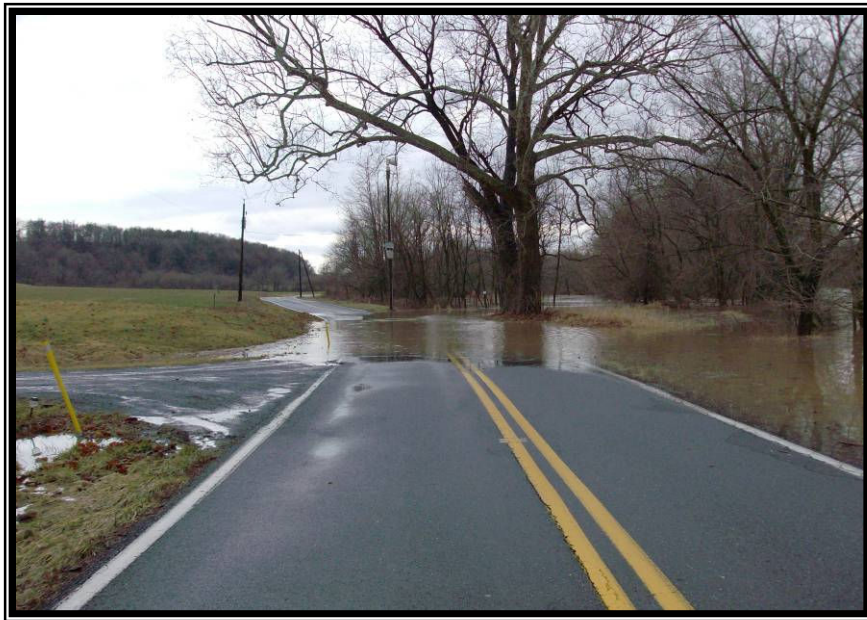
- Flooding of Bindnagle Road has been reported (Drawing No. 8 and Photo 15). A portion of Bindnagle Road is inundated periodically when Swatara Creek floods. The stretch of road that is primarily impacted starts approximately 2,100-feet north of the intersection of Bindnagle and Laudermilch Roads and runs for about 1,700-feet.

Photo 15 - Flooding at Bindnagle Road

- Relocate the affected portion of Bindnagle Road far enough east of the current alignment to raise it above flood levels. This would allow the road to be elevated several feet above the existing most frequent floodplain elevation of Swatara Creek.

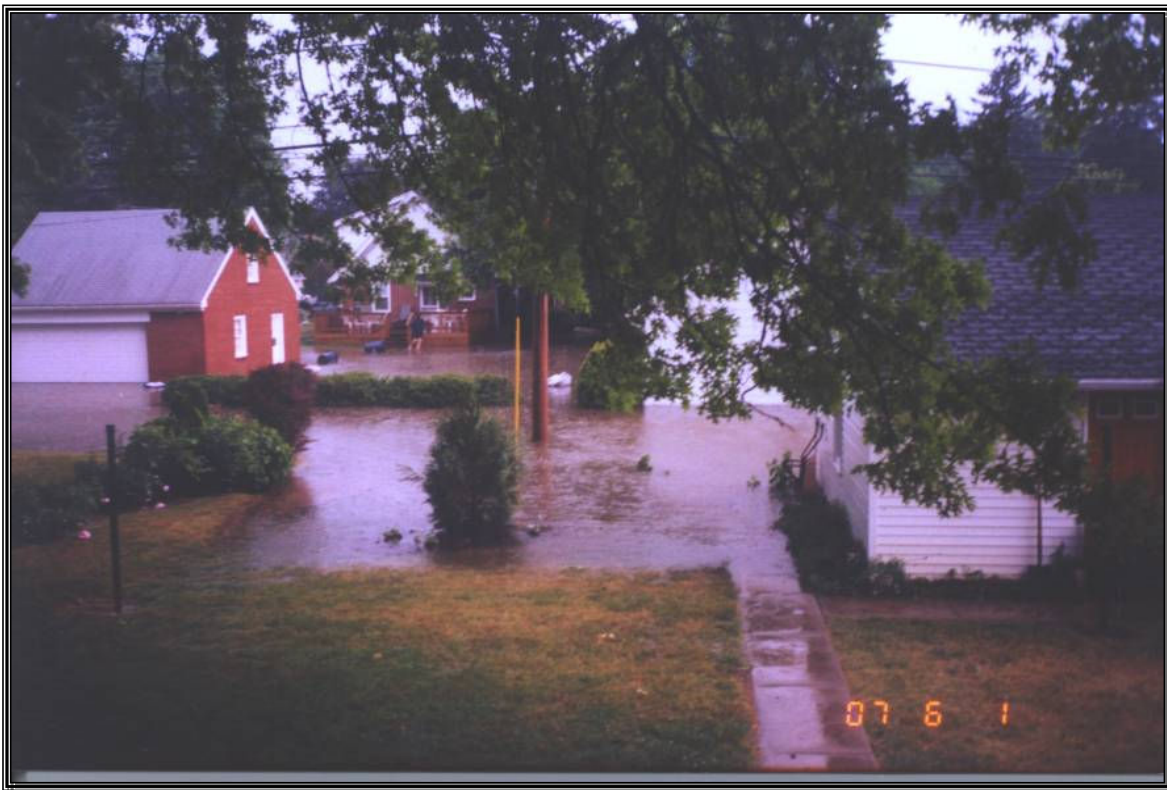
- Flooding occurs during large storm events along Cocoa Avenue at the intersection with Maple Avenue and along Maple Avenue and Elm Avenue and the local alleyways (6th and 7th Streets). The flooding has, on occasion, flooded garages and homes along the roadways (Photo 16).
- The cause of the flooding is the inadequate sizing of storm sewers and lack of sufficient inlets along the roadways.
- Also contributing to the flooding condition is backwater that can be generated due to surcharging of the major storm sewer system that runs under the Hershey School District's ball fields.

Photo 16 – Flooding on 6th Street during Hurricane Ivan, 2001

- A larger and extended storm sewer system is recommended following the alignment shown on Drawing No. 9.
- The storm sewer system would be comprised of 24-inch pipes and standard type "C" inlets.
- Additionally, a detailed study should be conducted of the capacity of the major sewer system that runs under the Hershey School District's ball fields to determine whether that system's capacity should also be upgraded.

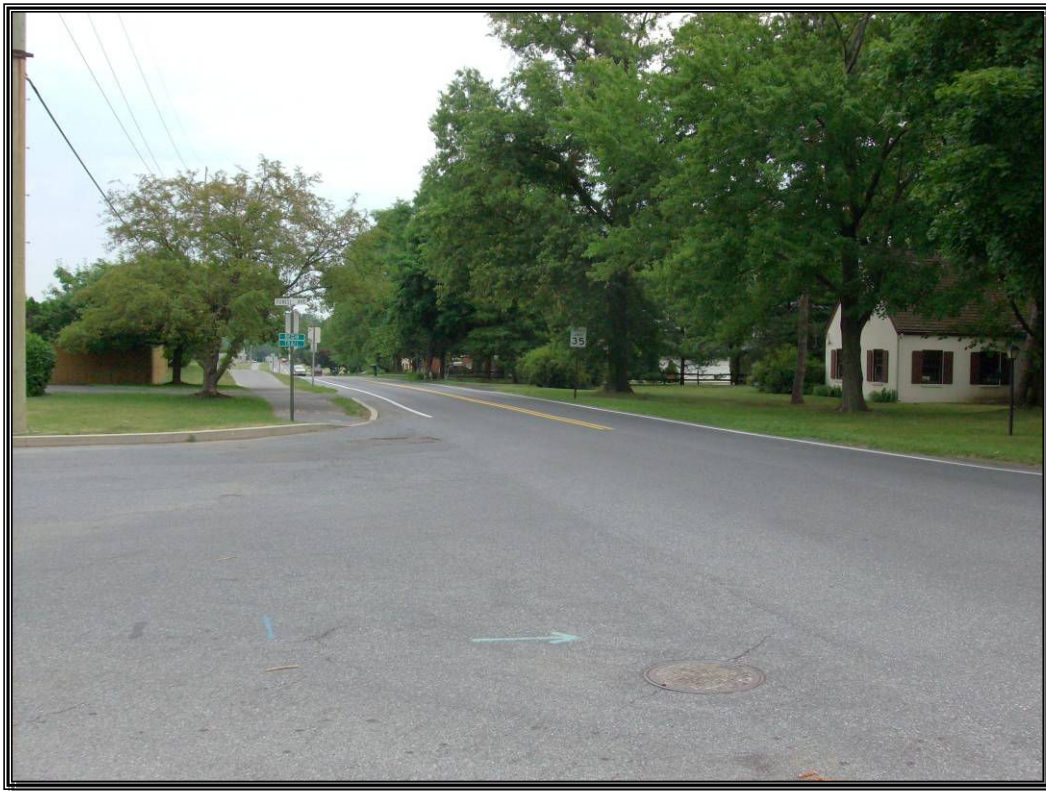
- Flooding occurs during large storm events at the intersection of Forest Avenue and Clark and Sand Hill Roads.
- Sand Hill Road south of the intersection is a steep hill and the runoff from this area concentrates at the intersection.
- The roadway intersection floods and then the yards also flood along the east side of Sand Hill Road, north of the intersection (Photo 17).

Photo 17 – Looking north at Sand Hill Road intersection

- A storm sewer should be constructed to collect the runoff from the three branch roads prior to reaching the intersection.
- The storm sewer would be extended north along Sand Hill Road as shown on Drawing No. 10 and would discharge into the storm sewer and pond system that connects to the Cherry Drive storm sewer.

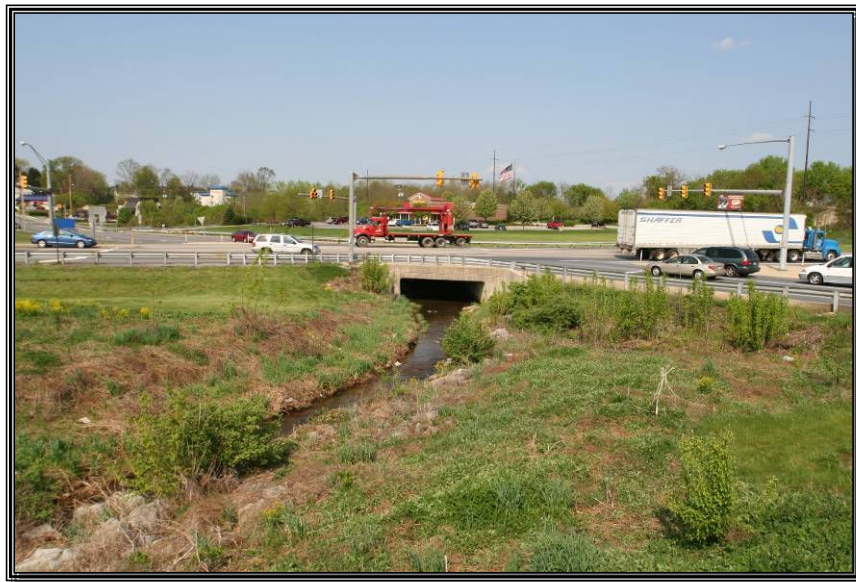
- There is an unnamed tributary to Swatara Creek that runs northward and parallel to the east side of Hershey Park Drive between Route 422 and Mae Street. The stream then turns under Hershey Park Drive (Photo 18), and flows westward for approximately 500 feet parallel to the north side of Walton Avenue before turning northward again to flow under the Norfolk Southern railroad embankment (Drawing No. 11).
- The culvert under the railroad embankment is 48 inches in diameter and becomes surcharged during medium to large storm events. When the water backs up at the culvert entrance, it eventually rises to flood portions of Walton Avenue, E. Main Street, and Hershey Park Drive, and portions of the shopping center on the west side of E. Main Street.

Photo 18 – Looking downstream at culvert under Hershey Park Drive

- First and foremost, the capacity of the culvert under the railroad embankment should be increased. This can be accomplished by boring two (2) 60-inch culverts through the embankment (existing 48-inch culvert to remain).
- If the capacity through the railroad embankment is increased, then the channel and two small driveway crossings in the Highmeadow Camp facility will have to be modified to handle the increased flows. Drawing No. 11 illustrates the locations of the culverts and channelization work.

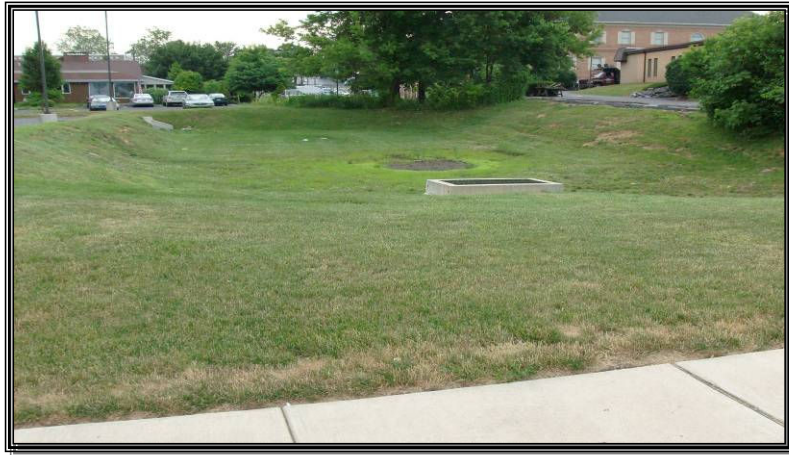
- There is a shallow detention pond on the east side of Lucy Avenue (Photo 19) that provides some control of the runoff from the heavily developed contributing watershed. However, during large storm events, the detention pond fills up and water flows over Lucy Avenue (Drawing No. 12).

Photo 19 – Looking at the detention pond on the east side of Lucy Avenue

- As illustrated on Drawing No. 12, it is recommended to install a 36-inch storm sewer system from the detention pond on the east side of Lucy Avenue westward past the driveway to Fudruckers Restaurant that has capacity for larger storm events.

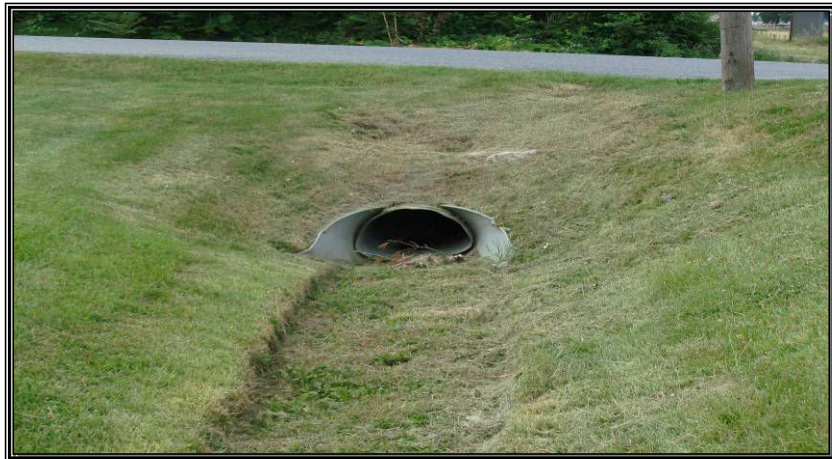
- On the west side of Lucy Avenue, there is an open channel that conveys water westward through a driveway culvert (Photo 20) and then to the culvert and open channel system serving the Route 422/322 intersection. The culvert under the driveway does not have capacity for large storm events and backwater causes flooding of the upstream property.

Photo 20 – Looking at the culvert under the driveway to Fudruckers Restaurant

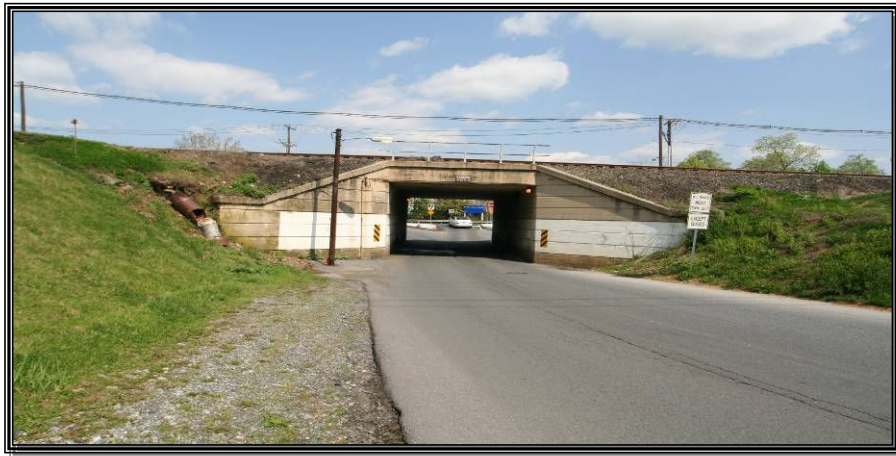
- The Mill Road underpass is the low point for a 60-acre drainage area that includes portions of Mill and Ridge Roads and W. Chocolate Avenue (Photo 21).
- In and around the underpass there are five (5) inlets, some of which appear to be partially clogged. The storm sewer that connects these inlets ultimately discharges to Swatara Creek.
- The storm sewers are under-sized for the drainage area and the underpass floods during large storm events, resulting in temporary road closures until the flooding subsides.

Photo 21 – Mill Road underpass

- Several of the inlets are quite small and difficult to keep clean. Replace those inlets with standard type “C” inlets.
- Replace the storm sewers with larger pipes (48-inch) to increase the capacity of the system.
- Replace the outlet pipe that runs from the underpass to Swatara Creek with a larger pipe (Drawing No. 13).

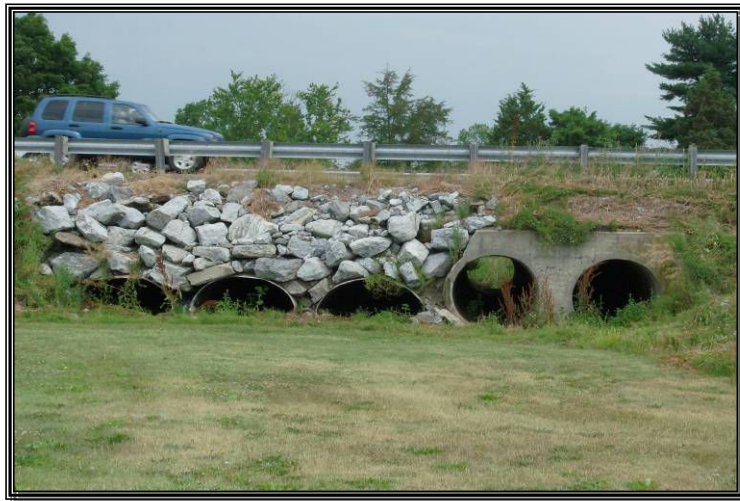
- Spring Creek runs through Palmdale Park and has a drainage area of approximately four (4) square miles at the culverts under Route 422 (Chocolate Avenue). However, there is no defined bed and banks for the stream due to significant sinkhole activity upstream. Runoff from most storms enters small sinkholes and flows directly to the groundwater table.
- During larger storm events, the groundwater table rises to the surface level and runoff continues to follow the low ground down to Palmdale Park, where it floods the baseball and soccer fields.
- The culverts under Route 422 (Photo 22) would have enough capacity to handle the flows, but the ground both upstream and downstream of the highway is so flat that it does not drain well.

Photo 22 – Looking north at culverts under Route 422

- Just upstream of the Park's access road, the U.S. Army Corps of Engineers constructed a levee that parallels 2nd Street. The purpose of the levee was to prevent flood flows from running northward into the yards of the homes along 2nd Street.
- It would be possible to modify and extend the levee so that it created a detention pond on the east side of the Park access road (Drawing No. 14). An outlet structure could be installed that would control the discharge to a level that would not flood the ball fields.

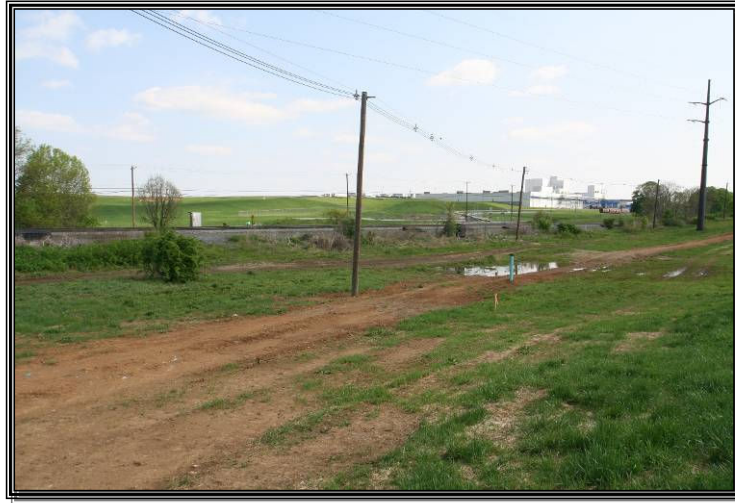
- Water ponds on the south side of the Norfolk Southern railroad tracks near Sipe Avenue (Photo 23).

Photo 23 – Looking east at railroad embankment from Sipe Avenue

- Install a storm sewer that would have an inlet at the upstream end and a discharge to the existing stream channel on the north side of W. Chocolate Avenue (Drawing No. 15).

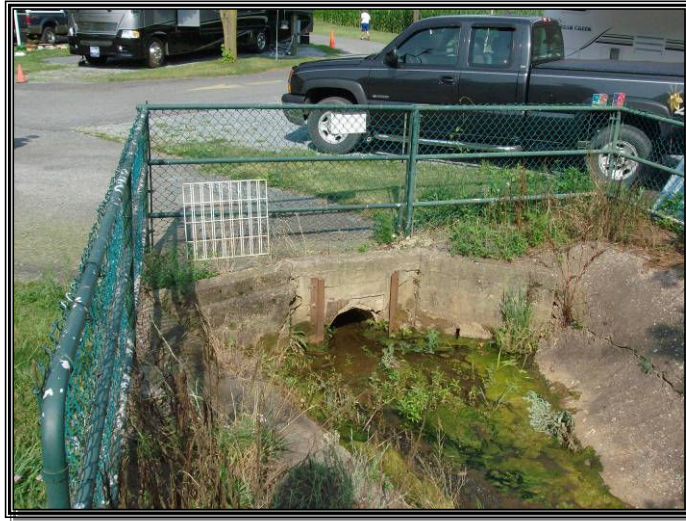
- An unnamed tributary to Swatara Creek flows through the Highmeadow Camp parking lot just west of Hershey Park Drive. There is a storm sewer that carries the flow under the parking lot (Photo 24) and discharges to an open channel on the west side. This storm sewer is undersized for the six (6) square mile drainage area of this stream.

Photo 24 – Upstream end of pipe under Highmeadow Camp parking lot

- Replace the existing storm sewer with a 36-inch pipe and increase the size of the open channel at the downstream end of the pipe (Drawing No. 16).

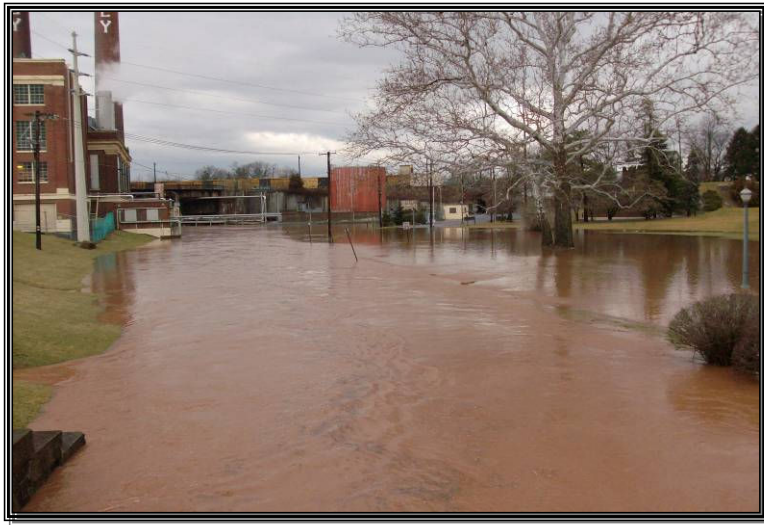
- Spring Creek flows past the Hershey Chocolate Plant and Hershey Park on its way to join with Swatara Creek. Along that stretch of stream there are a number of roadway, railroad, and pedestrian crossings that constrict the flow capacity of the stream channel. In addition, the stream has been channelized and portions of the floodplain were filled when the Chocolate Plant was built. As a result, large storm events cause backwater flooding along West Mansion Road upstream of the Norfolk Southern railroad culvert (Photo 25).

Photo 25 – Spring Creek looking north towards the railroad crossing – 3/5/08 storm

- The capacity of the stream crossings and channel between the Norfolk Southern railroad culvert and Swatara Creek must be evaluated and those crossings and channel segments that have insufficient capacity for a major storm event and should be enlarged. Based on a cursory analysis, there are at least six (6) crossings, shown on Drawing No. 17, which will probably have to be replaced. In addition, the channel and floodplain area will have to be enlarged to handle severe events.
- In lieu of replacing the crossings, it may be possible to construct a flood control (detention) pond upstream of W. Chocolate Avenue on property owned by Milton Hershey School. This area would have to be surveyed and a detailed hydrologic and hydraulic analysis would have to be conducted to evaluate the feasibility of this solution.
