APPENDIX D PROBLEM AREAS AND OBSTRUCTIONS

PROBLEM AREA IDENTIFICATION

Municipalities Reporting Problem Areas and Obstructions
 Dauphin County Act 167 Plan
 Dauphin County, PA

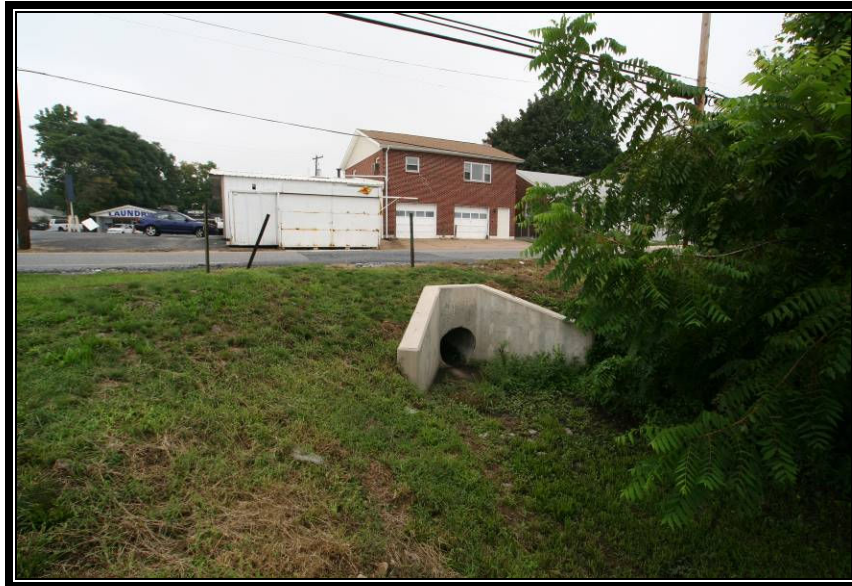
- The existing 36-inch storm sewer goes northward under a building between East Main Street and Walton Avenue and continues north under the Norfolk-Southern Railroad (Drawing No. 18).
- Recently, an additional 48-inch pipe was constructed under the railroad embankment. However, the upstream pipe was not improved.
- There have been reports that portions of the 36-inch pipe have partially collapsed. Prior to the collapse, the pipe was undersized and caused stormwater flooding at the intersection of East Main Street and Walton Avenue (Photo 26).

Photo 26 - Stormwater inlet under East Main Street

- It was determined that a 60-inch pipe should be constructed under East Main Street and Walton Avenue all the way to the railroad embankment to pass the 25-year storm event. The new stormwater system will replace the existing collapsed 36-inch pipe system for improved capacity to reduce flooding during larger rainfall events. Drawing No. 18 shows a plan view of the proposed engineering solution to the flooding problem at this site.

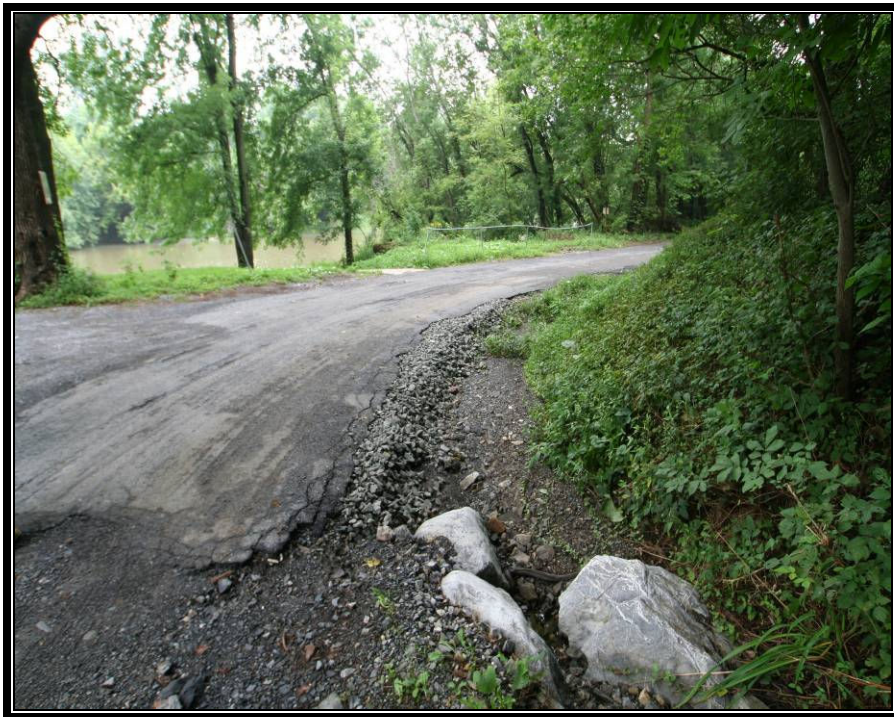
Photo 27 - Road leading to Hammond Property

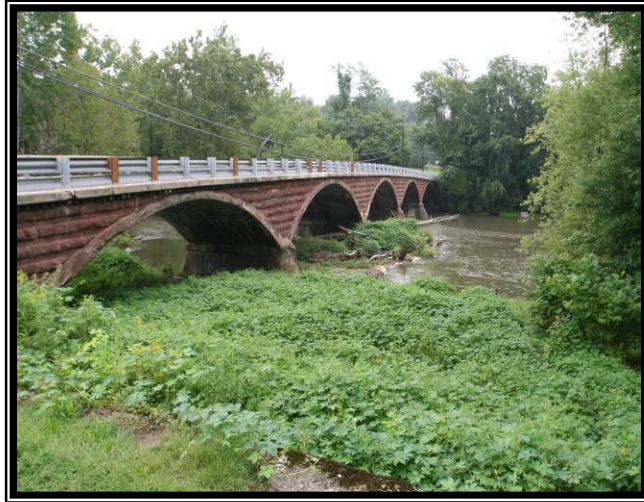
- North Duke Street bridge over Swatara Creek causes flooding problems to the adjacent streets and properties (Drawing No. 20).
- Sediment and debris partially block part of the waterway opening (Photo 28).

Photo 28 - Debris blocking the waterway opening of North Duke Street Bridge

- Remove the debris and sediment from the bridge opening. Photos 28 and 29 show that most of the debris blocking the bridge opening is tree branches and accumulated sediment.
- The drainage area contributing to this site is 514-square miles. If the Borough plans to replace the bridge, any new hydraulic structure should be designed to pass FEMA's 100-year flood event (47,000-cfs).

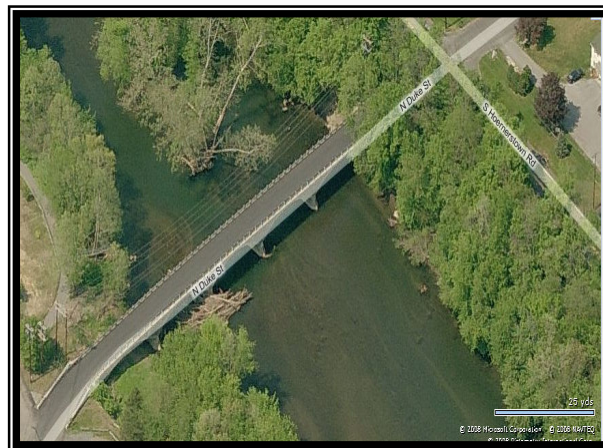
Photo 29 - Aerial View of North Duke Street Bridge

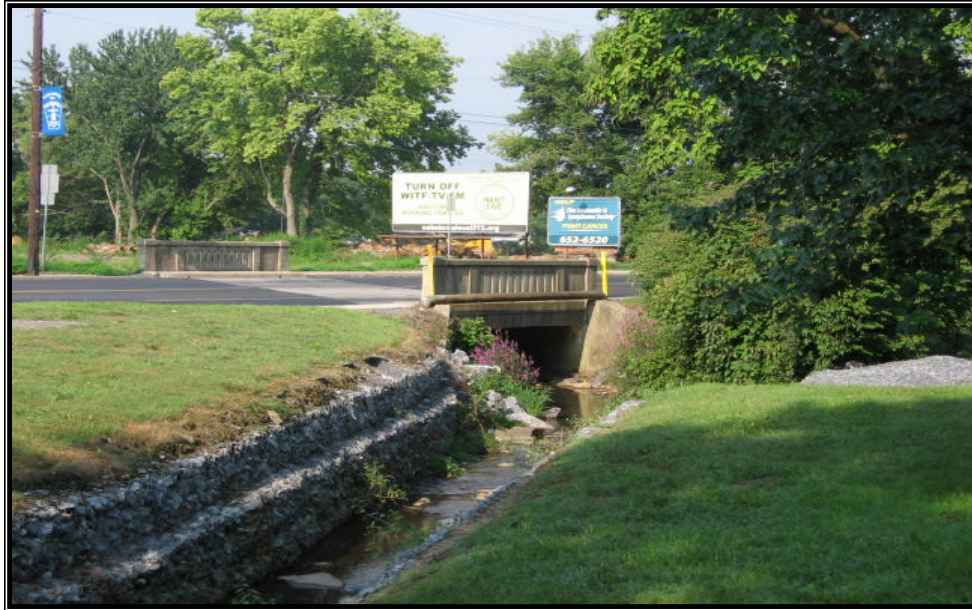
Photo 34 - Burd Run stream stabilization work

- The results show that most of the stream has very high potential for stream bank erosion. Therefore, it is important to develop a solution that fits with the dominant environmental conditions.
- It is recommended that the channel stabilization work be continued with some adjustment to incorporate more vegetation into the bank stabilization measures (Drawing No. 21).

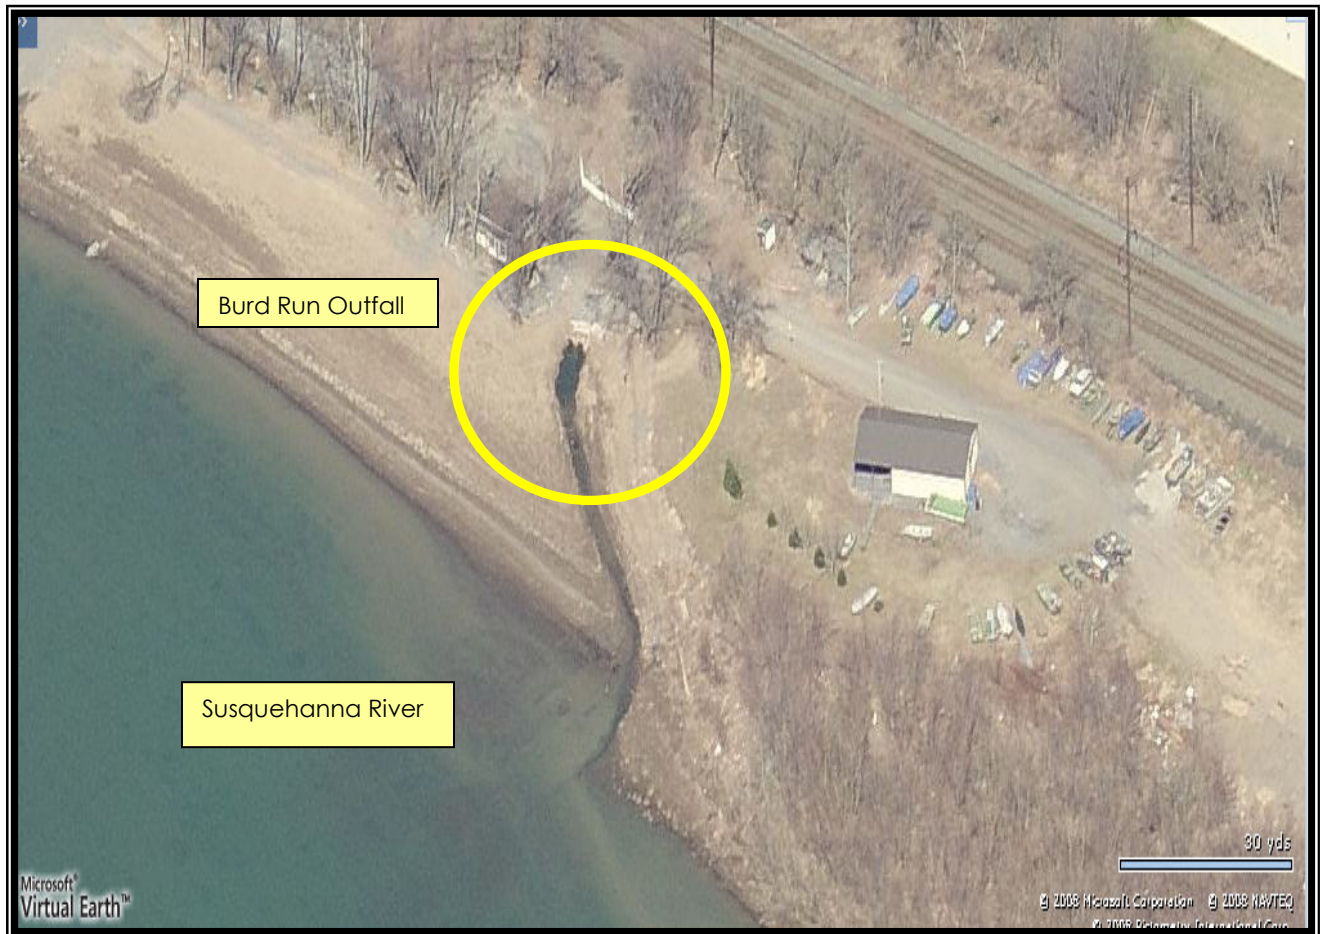
Photo 35 - Burd Run Watershed Outfall

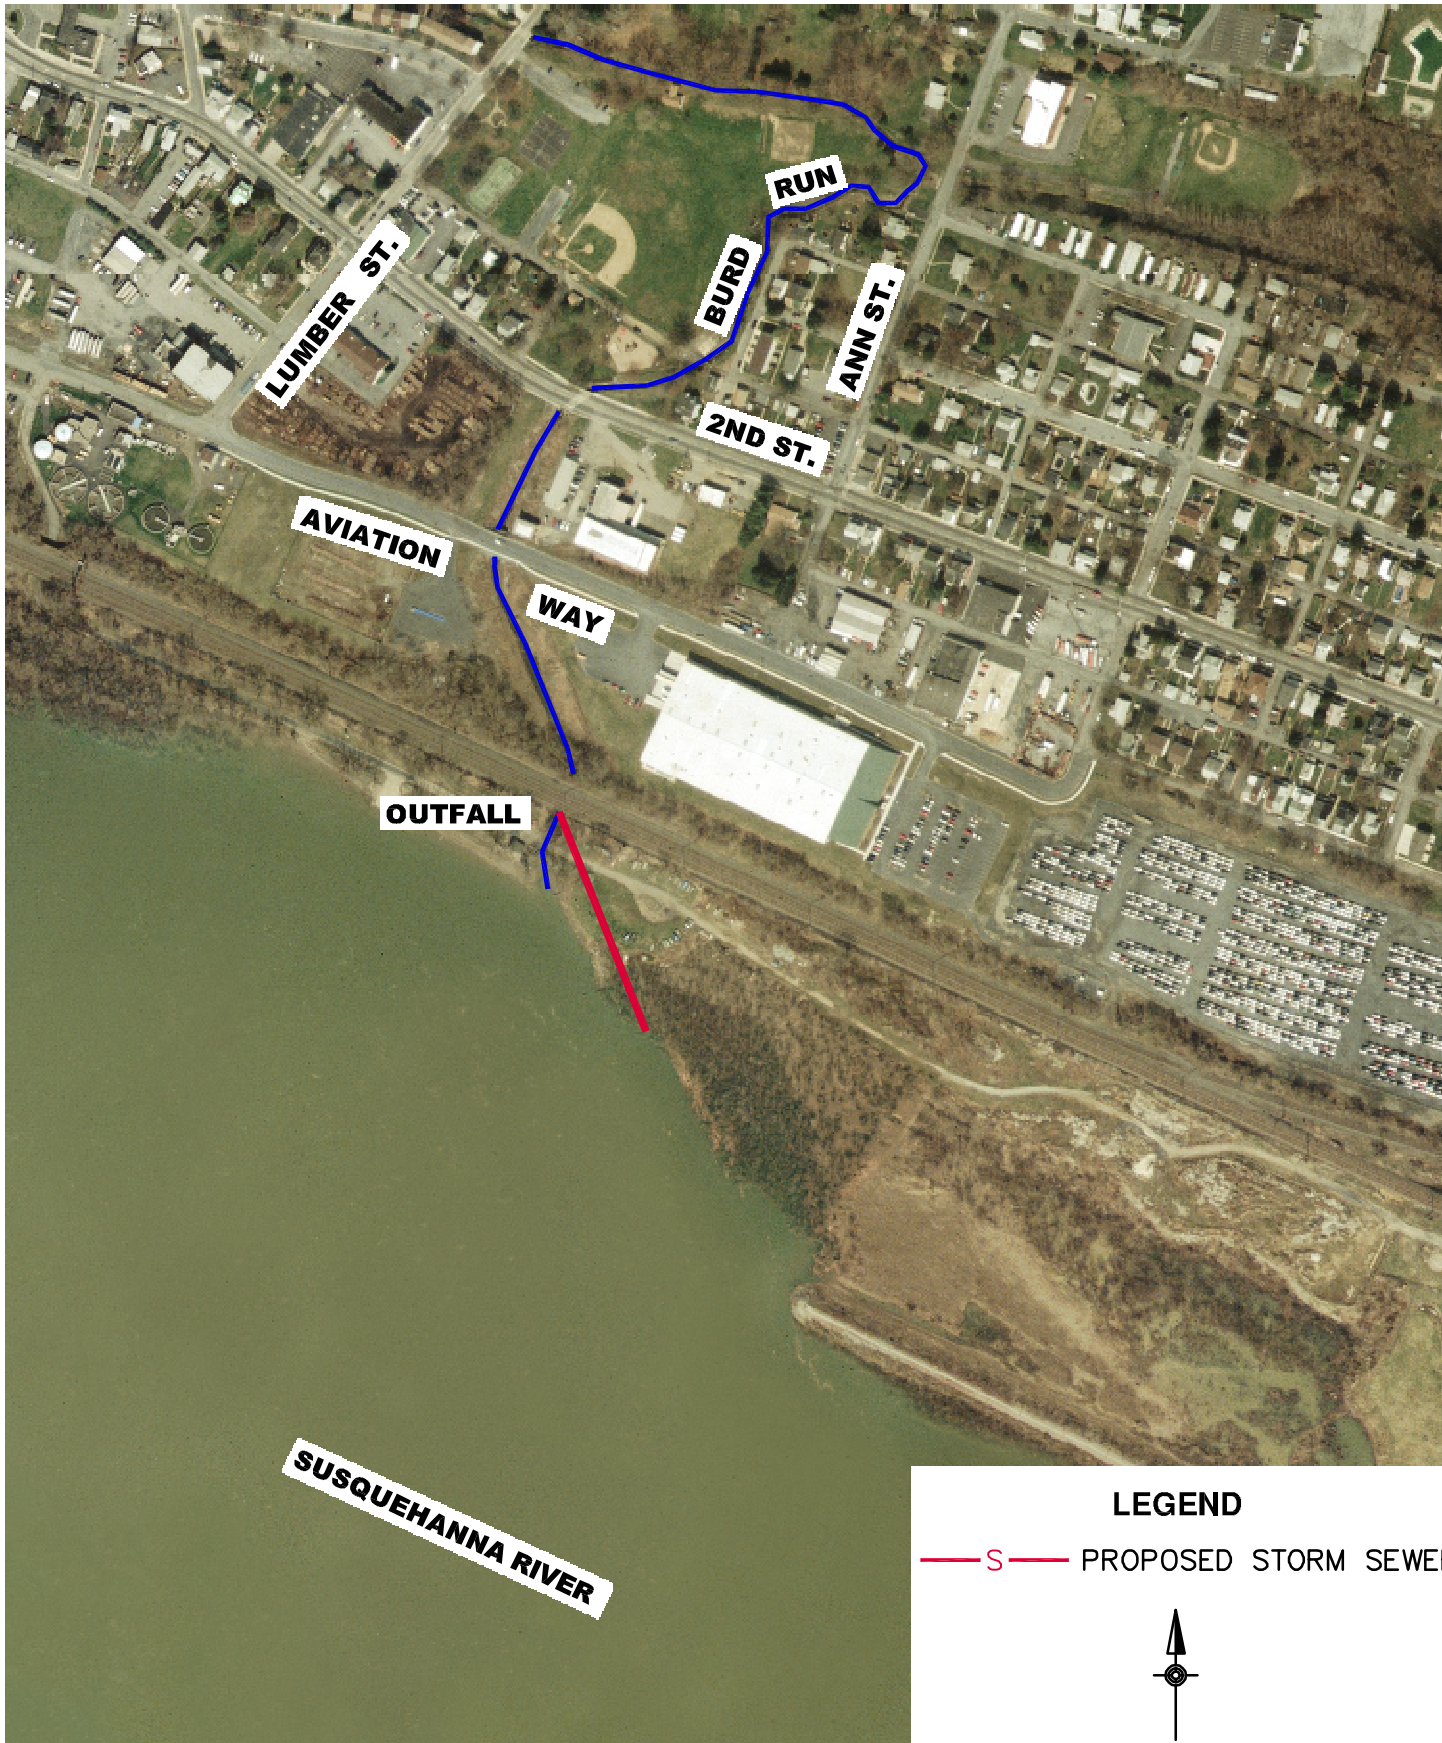
- Clean the pipe and outflow channel periodically.
- If this does not solve the problem or becomes too costly, extend the pipe closer to the main channel of the Susquehanna River (Drawing No. 22).

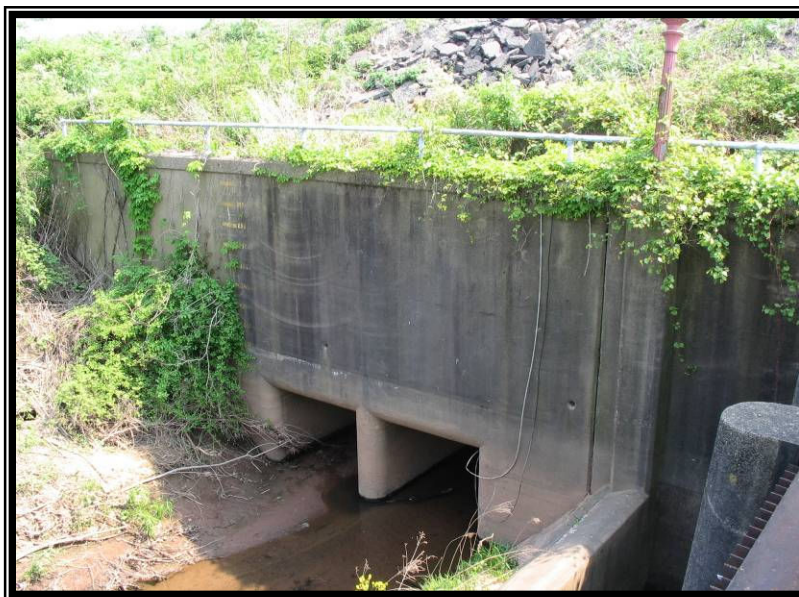
- There are three main reasons for the flooding problem:
 1. The flatness of the terrain;
 2. The inadequate capacity of storm sewers and culverts that exist between Jednota Flats and the discharge point of Post Run on the Susquehanna River and between Route 230 (W. Harrisburg Pike) and Swatara Creek. These culverts and pipes do not have sufficient capacity to convey peak discharges from even a 2-year storm event and their capacity is severely reduced when Swatara Creek and the Susquehanna River flow levels rise enough to cause backwater conditions, and;

Photo 36 – Levee primary outlet culverts at HIA

- The estimated cost of the water pumping system is \$12,500,000 (2007 dollars).
- The location of the recommended facilities are shown on Drawing No. 23.

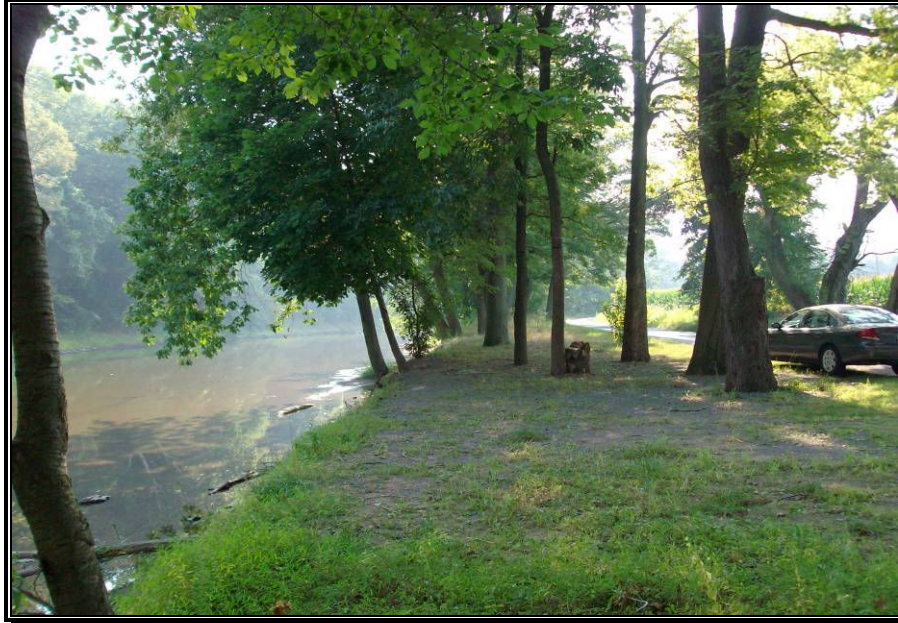
- A flooding problem has been reported along Snyder Mill Road just upstream of Route 147 (Drawing No. 24). In addition, some debris was observed at the Route 147 bridge opening.
- The road is located in the floodplain of Mahantango Creek (Photo 37).

Photo 37 - Standing on the left overbank of Mahantango Creek

- As illustrated on Drawing No. 24, relocate and elevate the roadway to be higher than a selected design flood elevation of Mahantango Creek. This will prevent future damage and keep the roadway in service during large flood events. However, further investigation needs to be conducted to ensure that raising the roadway elevation would not increase upstream flood elevations and create a backwater effect.
